Kirkby Cross Conservation Area Appraisal

Ashfield District Council
Adopted September 2004

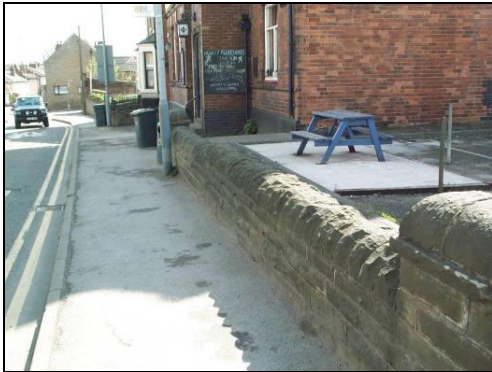
1) Sherwood House Inn and adjoining car park.

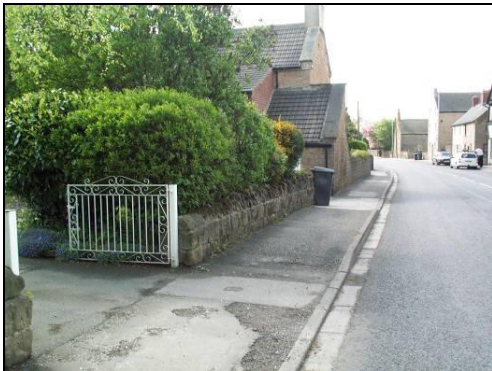
2) Wall to the front of Ewtor, Church Street.

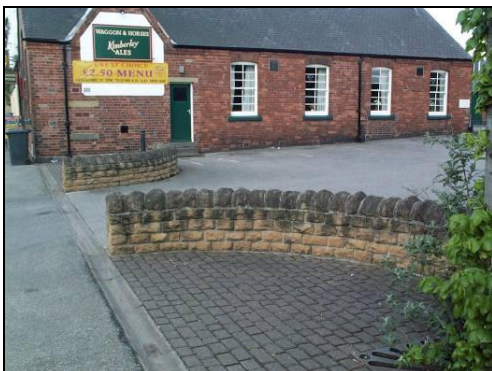
3) Wall to the front of the Waggon and Horses car park.
