## Sutton in Ashfield Church and Market Place Conservation Area Appraisal & Management Plan

March 2015

**Title:** Ashfield District Council: Sutton in Ashfield Church and Market Place Conservation Area Appraisal and Management Plan.

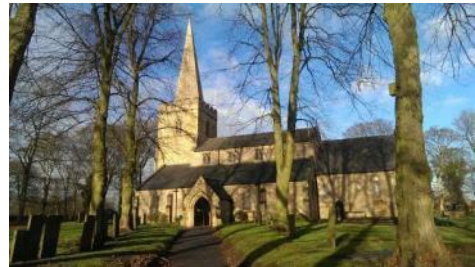
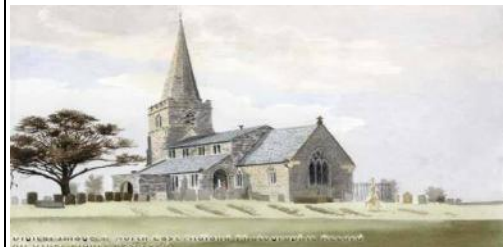
Figure 18: The church as painted in 1868.

**Church of St Mary Magdalene** is a Grade II\* listed building and the oldest surviving building in the conservation area. Dating from the 12th century with the tower and spire constructed c1395. The chancel was rebuilt in 1854 with the church undergoing restoration in 1867 under the Rev. Charles Bellairs, vicar, at this time the aisles were also enlarged by the removal of pews and galleries and a wall and palisade were erected around the greater part of the churchyard. The east window was replaced in 1907. The church is built from coursed and squared rubble and dressed stone with gable and lean to slate roofs. The church benefits from a battlemented square tower topped by an octagonal spire totalling and height of 95ft.

The entrance gates to the churchyard from Church Walk consist of iron gates and railings. The stone gates piers original were topped with lamps whilst each pier had metal plaques attached. These plaques are understood to have read "These gates were erected by Public Subscription in grateful memory of those men and women of this town who laid down their lives in the World War 1939-1945".<sup>17</sup> The plaques have been replaced with stone versions during 2014.

Condition: Good

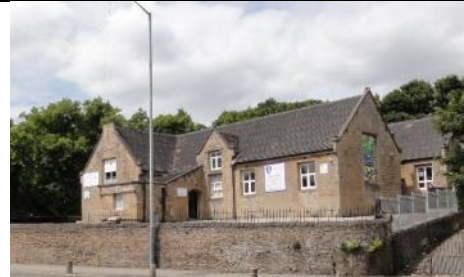
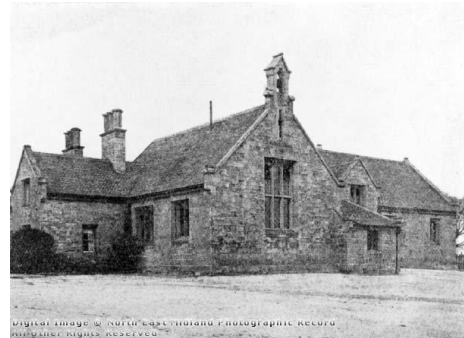
Figure 20: The National School. Date unknown.

**The National School** occupies an elevated position overlooking Lammas Road. It was built in 1845 in a Tudor-Gothic style to replace the earlier National school that was founded in the old Tithe Barn, which stood to the west of the present school in 1919. The new school originally provided for upwards of 200 children, later classroom additions in 1867 and an infant's room in 1882 enabled the school to provide education for over 400 children. The school originally had a teacher's residence too.

Condition: Fair.

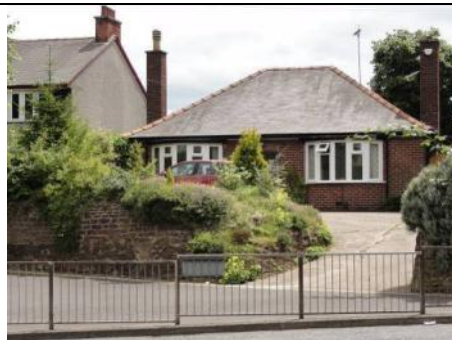
**Number 11 Church Lane** is a detached house built between 1919 and 1940. It has a simple ridge slate roof and roughcast render. The garage appears to be a later addition to the original building. The original steel frame leaded casements have been replaced with UPVC.

Condition: Good

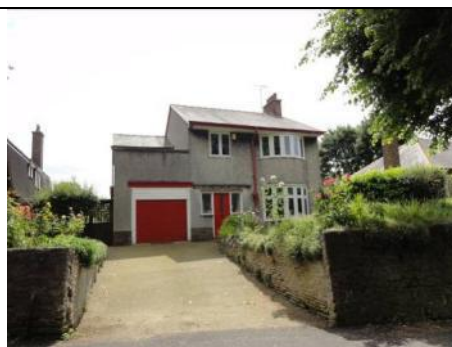
**Number 9 Church Lane** is again constructed between 1919 and 1940. Architecturally the building is very distinct due to its plain tile covered gambrel roof. The use of feather boarding, half timbering, render, brick and stone create a unique and aesthetically pleasing property. The property also benefits from the retention of its original steel casement windows.

Condition: Good

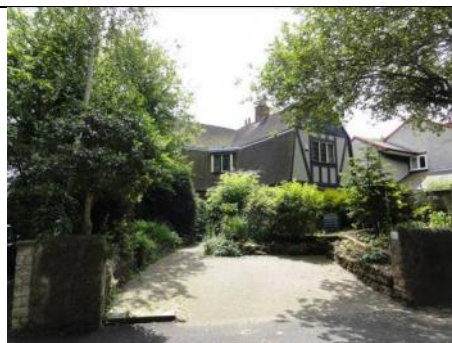
**Numbers 5 and 7 Church Lane** is a semi-detached house built between 1919 and 1940. Architecturally it is typical of the many semidetached houses built nationally during the 1930s with its plain clay tile hipped roof with finial details, central chimney stack, half-timber gables, bay windows and roughcast render finish. Number 7 has maintained more of its original appearance with its unpainted render and leaded windows. Whilst not architecturally unique in a wider sense

<p>numbers 5 and 7 contribute to the group value to the lane and stand as a unique pair of houses within Church Lane itself.</p> <p>Condition: Good</p>	
<p><b>Number 3 Church Lane (The Chantry)</b> is a brick and roughcast rendered detached house with a sweeping plain clay tile roof and half-timbered gable to the front. The property benefits from well detailed chimney stacks. The property dates from between 1919-1940 but its strong Arts and Crafts influence in the design suggests it was built to the earlier years of this date range.</p> <p>Condition: Good</p>	 
<p><b>The Spinney Church Lane</b> is, like number 9 a very distinct detached house due again to its gambrel roof but this time covered with Roman clay tiles. Its roof shape, and colour contrast of white rendered walls against the red clay roof ensure its prominence in the lane. The building was again constructed between 1919 and 1940 on the site of the former grounds of Westfield House.</p> <p>Condition: Good</p>

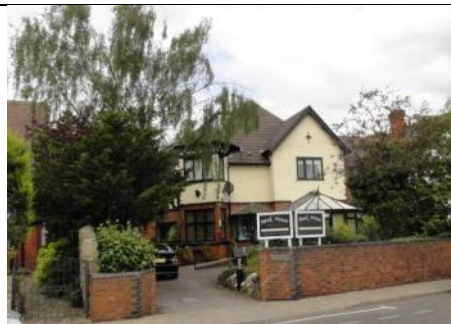
**Kirkstede, Church Street** is again a large detached house in generous grounds built between 1899 and 1919.. Red brick, half rendered with half timbering. Under a plain clay tile roof and finials with lead roofs to the canted bays. The property has lost its original windows now with PVC-u throughout but the property benefits from retaining its original front boundary wall. Kirkstede was once the home of George Gershom Bonser (d. 1947) an eminent local historian and Councillor.

Condition: Good

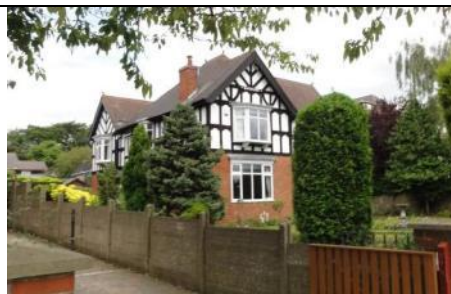
**Riversdale and Heathfield, Church Street,** semi-detached house, red brick and plain clay tile roof with tall chimney stacks. Built in 1906 according to the date stone set in the front gable. It has a symmetrical frontage with most of the original style timber sash windows retained. Square bays to ground floor with leaded roofs. The building using brick and terracotta decoratively as can be seen with the egg and dart patterning at the eaves, decorative ridge tiles and finials. The building also retains its original arcaded boundary wall with half round copings and gate piers which are particularly attractive. The building is largely original in appearance.

Condition: Good

- 5.23 Boundary walls built from brick are few in the conservation area however those of note are found along Church Street. The front boundary walls to Lindum, The Limes, Heathfield and Riversdale are good examples reflective of these quality 19<sup>th</sup> century properties. The boundary to Heathfield and Riversdale is particularly unusual with its brick arcade topped with half round brick copings. Some of the boundaries between properties along Church Street are also noteworthy either reflecting the front boundary brick walls or are high stone walls.

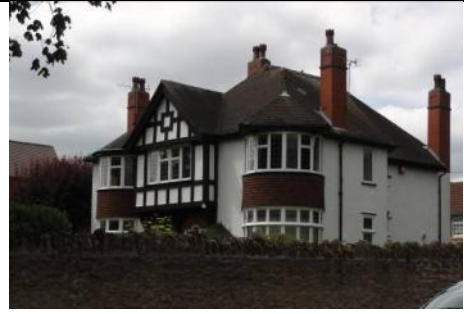
**The Croft, Church Street** is again a large 2 storey house that occupies a corner plot set behind a stone boundary wall. Built between 1919 and 1940 with a brick ground floor and roughcast rendered first floor under a plain clay M-plan roof with sprocketed exposed eaves. All windows are PVC-U, those at the first floor are under tile creased lintels with ground floor windows having simple stone lintels. The building is reflective of the Arts and Crafts period.

Condition: Good

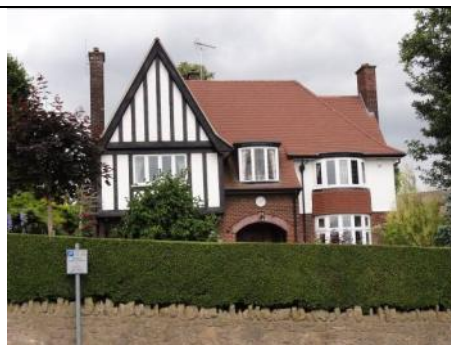
**Eynord, Church Hill** is an attractive 2 storey brick and rendered house built between 1919 and 1940. It has a plain clay tile roof with prominent chimney stacks and a half timbered steeply pitched gable to the front. The decorative arch to the porch is particularly notable. All windows are PVC-U with the exception of the centre dormer which retains its original metal casement with leaded glass.

Condition: Good

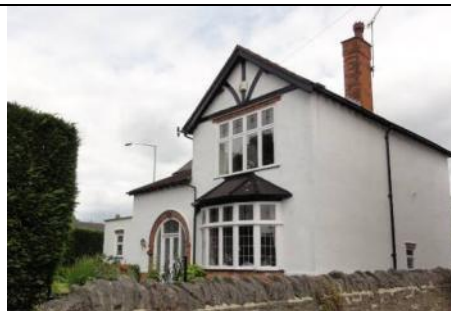
**Kirkside, Hack Lane** occupies a corner plot and is a 2 storey detached house built between 1919 and 1940. The house is roughcast render set on a brick plinth under a plain clay tile roof with chimneys retained. To the front the building has a half timbered gable and lead roof curved bay window at ground floor. The building benefits from its retention of its original leaded casements with coloured glass. Lintels to windows and doors are tile creases providing a decorative element. To the side is a 1930s garage.

Condition: Good

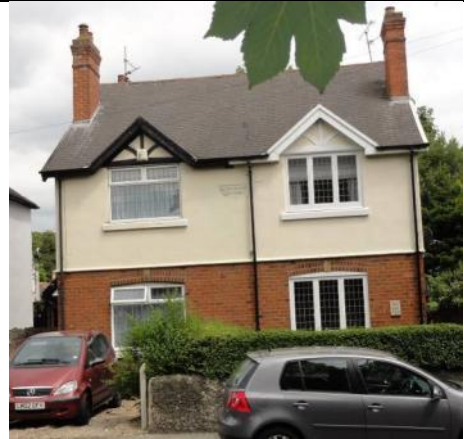
**2 & 4 Hack Lane (Capesthorpe Cottages)** is a semi detached house with brick ground floor with roughcast rendered gable walls. The first floor to the front is also rendered but scored to appear as ashlar stone blocks. The roof is slate, with timber barge boards and soffits and all four chimneys are retained. To the front above the first floor windows are half timbered gables. The windows at number 4 have all been replaced with PVC-U, while number 2 has timber leaded casements in an original style. The name "Capesthorpe Cottages" is set in a stone centrally between the first floor front windows.

Condition: Good

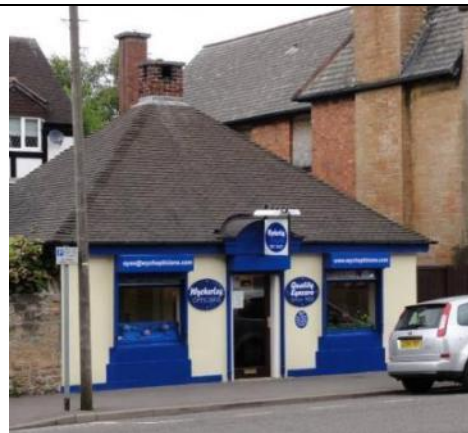
Figure 22: The opticians and the Old Police Station in the 1930s.

**The Old Police Station, Brook Street** was built in 1915 to replace the original police station that was built in 1861 on Albert Square. The building is neo-tudor in style with ashlar and rusticated stone frontage and brick to the rear. Its steeply pitched slate roof with deep exposed eaves rafters and three stone coped gables to the front ensure that the building is highly prominent on the street scene. The building retains its stone mullioned windows to the front with metal casements and carriage entrance. The building has high aesthetic value to the conservation area.

Condition: Fair & vulnerable.

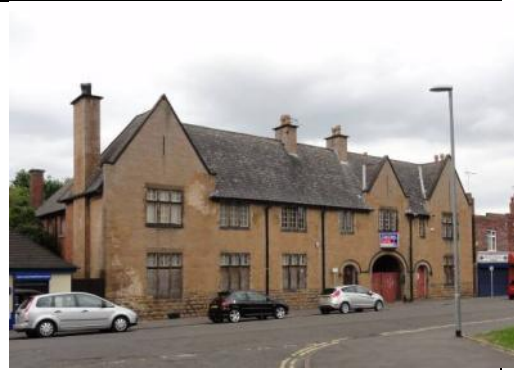
**Broadway (1-4) Brook Street** is a stark contrast architecturally when compared to the Old Police Station adjacent. Broadway was constructed between 1919 and 1940 (although number 4 appears to have been rebuilt) and is a brick built two storey commercial premise. It has a tile creased steeped parapet which were commonly used in the first half of the 20<sup>th</sup> century. Some of the original retail units at ground floor have been lost and infilled with brick. The building has lost its original windows which were likely to have been timber sash windows and the original shopfronts have been lost. The applied cut lettering "BROADWAY" below the parapet is not believed to be original to the building however the typeface is consistent with that of the 1950s and 60s. The building is considered to be a neutral building with regards to what it contributes architecturally to the character and appearance of the conservation area but the reinstatement of original windows and shopfronts would greatly enhance this building.

Condition: Good

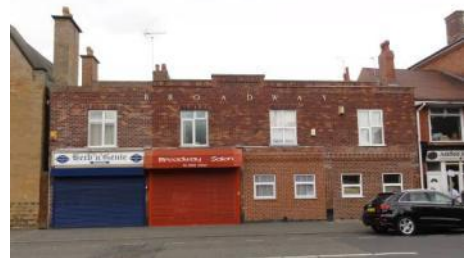
**20 Brook Street** is a two storey retail property. It is brick built with plain clay tile roof with sprocketed eaves and a prominent chimney stack to the front. The building was built between 1919-1940 and retains an early 20<sup>th</sup> century shopfront cornice, corbels and awning attached to brick quoins. Original joinery and rainwater goods have been lost, now all PVC-U. The building is considered to be a neutral building with regards to what it contributes architecturally to the character and appearance of the conservaiton area but the reinstatement of original windows and shopfront would greatly enhance this building.

Condition: Good

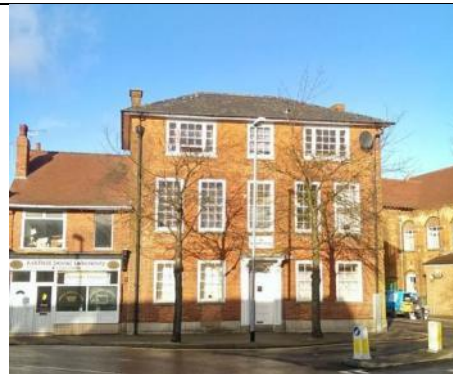
**The Old Post Office, Brook Street** is a 3 storey building built to reflect an 18<sup>th</sup> century (Georgian) town house. The building was built between 1919 and 1940. The building has a hipped slate roof. Original timber sash windows replaced in 2014 with PVC-U, all windows set under flat arch gauged brick lintels. The building is designed to face both Brook Street and Morwen Avenue although its principal elevation is considered to be Brook Street where the central door with decorative timber doorcase, hood and fanlight can be found.

Condition: Good

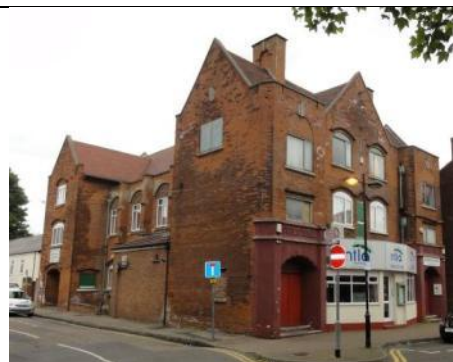
**The Old Welcome Institute and Cafe, Brook Street** is a prominent building just off the Market Place, 3 storeys, brick built with plain clay tile roof, two decorative chimney stacks, strong central gable and side parapets. The facade is symmetrical with two entrance doors with stone cut lettering above "Public Hall" in distinctive art nouveau typeface. The side elevation to Morven Street is defined by two bookend gables sandwiching the central hall with full height buttresses. The building contains much architectural but subtle detailing for example the stone geometric key stones, brick drip hoods and decorative rainwater

hoppers. Regrettably the building has lost its curved central entrance and balcony railings, original doors and leaded windows.

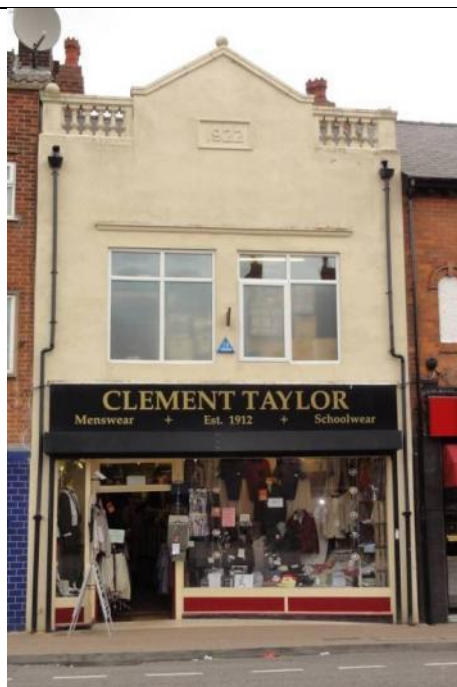
**6 Brook Street (Clement Taylor)** is a two storey building with rendered facade and slate roof with balustrade parapet and central pediment. The date “1922” is inscribed within the pediment. The balustrade and parapet are adorned with ball finials, some of which have been lost. The ground floor contains a timber shop front with recessed terrazzo lobby or 1960s appearance.

Condition: Good

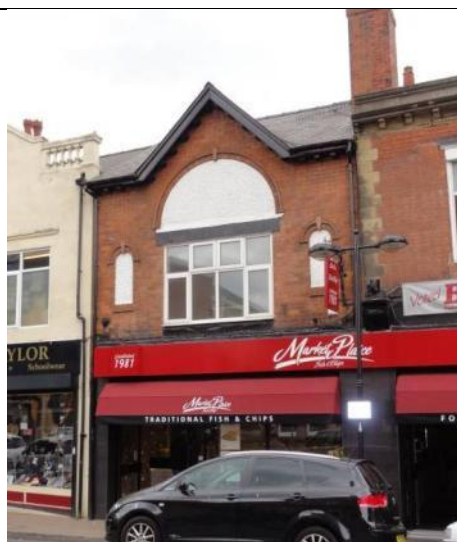
**4 Brook Street (Market Plaice Fish & Chips)** is a two storey building brick built with slate roof and prominent chimney stack. The frontage has a central gable emphasising the timber soffits with exposed rafter detailing. The central PVC-U window at first floor has a large timber lintel with decorative brick arch above with roughcast render beneath. This central window is flanked by two render infill arches. The ground floor has a modern tiles shopfront and signage.

Condition: Good

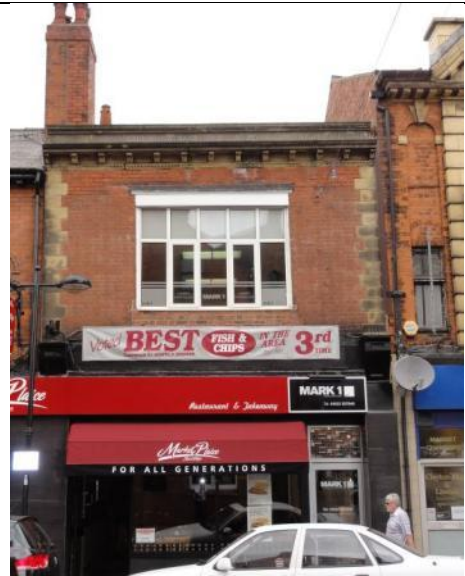
**4 Brook Street (Market Plaice Fish & Chips)** is a two storey building with notable stone decorative parapet and cornice and quoins set within a brick facade. The large central window is PVC-U no doubt having replaced a timber casement window. The ground floor retains original shopfront corbels although the rest of the ground floor is a modern tiled shopfront.

Condition: Good

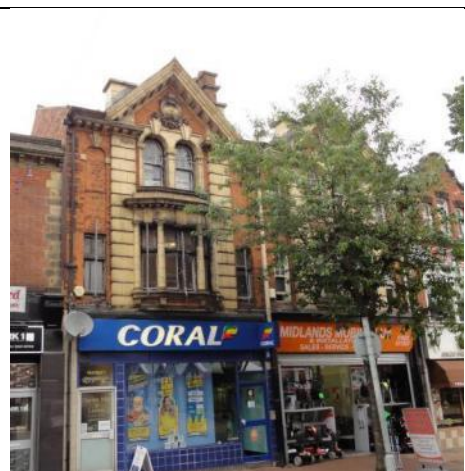
**Coral & Midlands Mobility, Market Place** is a three storey building of brick and stone with a highly decorative facade. Stone rusticated pilasters appear to support two front gables with dentilated cornice and eaves. Set within the gables are two decorative shields with the building's construction date of 1906 in Roman numerals.

The facade is not symmetrical as evidenced by the left hand bay which has a projecting bay window at first floor. The use of Tuscan columns at the first floor provides a very classical element to the facade. There is a combination of timber sash windows and casement windows, some with leaded and coloured glass which again emphasises the lack of symmetry across the facade. The building retains its decorative rainwater goods and the right hand shopfront retains its original curved glass, lobby and entrance door although all set behind a modern roller shutter.

Condition: Fair

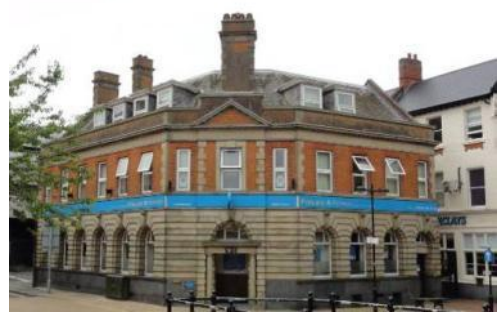
**Number 1 Low Street /Albert Square (Fidler and Pepper Solicitors)** is a prominent canted corner building overlooking Albert Square and the Market Place on the site of a former police station. Built between 1875 and 1899 from brick and stone it is 2.5 storeys high with slate roof punctuated by six flat roofed dormers and three chimney stacks. The façade has a number of decorative elements including a parapet, stone quoins, dentilated cornice, and central pediment. The ground floor sits atop a granite stone plinth and is a rusticated stone façade where all timber windows sit within decorative arches with prominent key stones. The central door is particularly ornate sitting between Tuscan columns. Windows to upper floors have been replaced with PVC-U.

Condition: Good

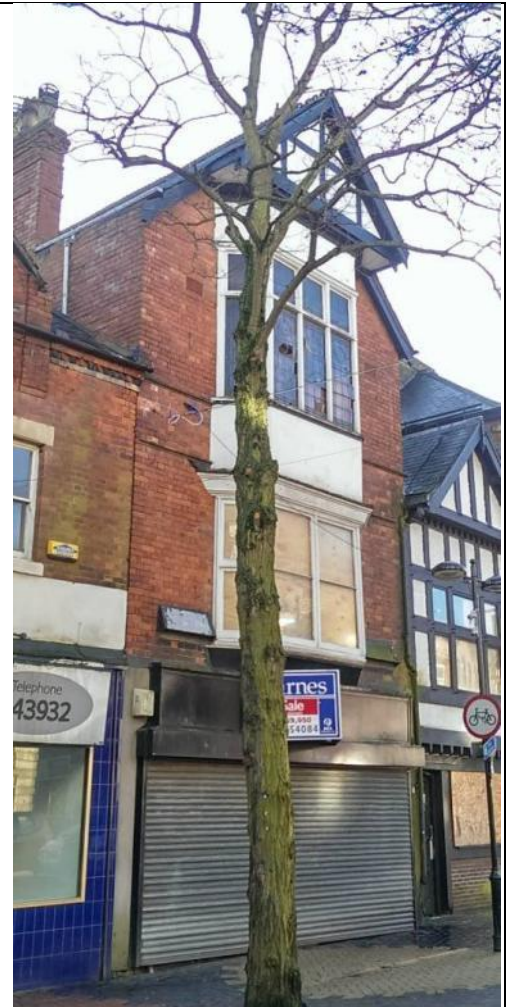
**4 Low Street**, is a late 19<sup>th</sup> century 3 storey brick built building with slate roof. The ground floor has a modern shopfront but the upper floors have retained their original canted bays. The second floor bay has attractive leaded windows. The bays are topped with a half timbered gable. To the left the building has retained its large chimney stack.

Condition: Fair (currently being renovated).

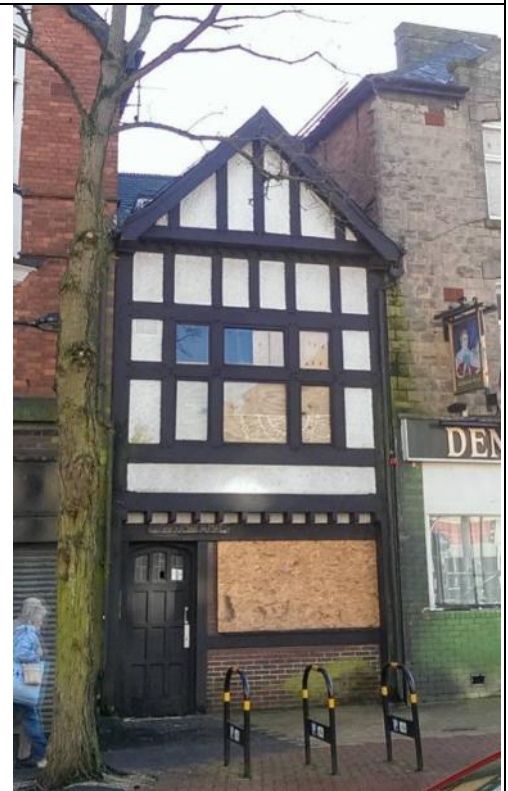
**2 Low Street**, is an early 20<sup>th</sup> century that appears to have been constructed in an in fill plot. The building is 2 storey, half timber and smooth render with slate roof. The first floor is jettied providing a mock Elizabethan appearance. The ground floor has a timber and brick shopfront consisting simply of a door and windows. The first floor retains steel casement windows.

Condition: Fair (currently being renovated).

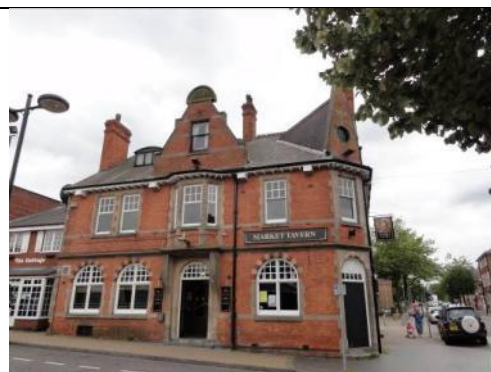
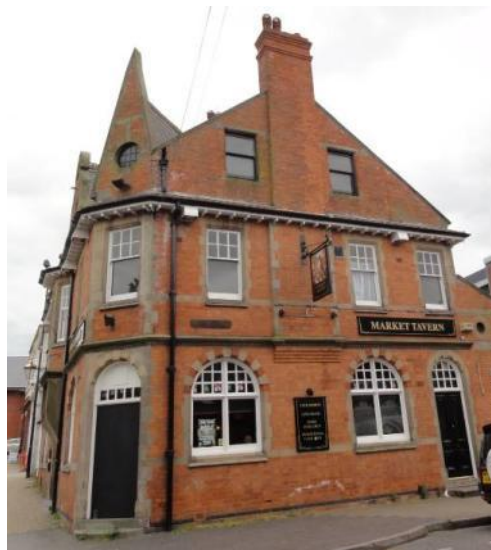
**The Cottage, Market Place**, is a 2 storey building built of brick with slate roof. It building is late 20<sup>th</sup> century typical of the late 1970s and early 1980s. The building is of no architectural or historic value to the conservation area.

Condition: Good.

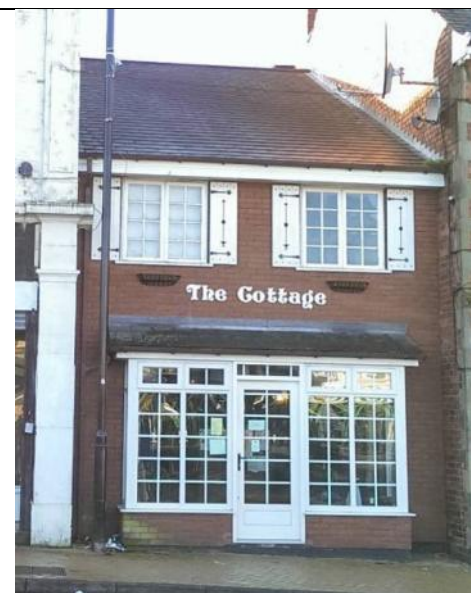
**4a Market Place**, is an early to mid 20<sup>th</sup> century brick and stone 2 storey flat roofed building with painted brick facade and stone pilasters to shop front. Shopfront is modern aluminium. The building is loosely influenced by the Moderne style popular at the time.

Condition: Good.

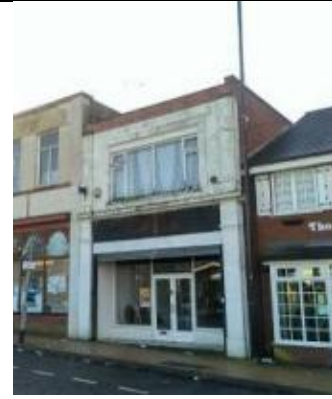
**Unist 3 & 4 Market Place/King Street**, Was built between 1899 and 1919. Originally the building was 1 shop unit and had a brick façade interrupted by stone pilasters with timber sash windows the first floor. At ground floor were Edwardian/Moderne styles shopfronts with low stallrisers and pull out awnings. The majority of this original fabric has now been lost only the quadrant shape of the building provides any architectural interest of the conservation area.

Condition: Good.

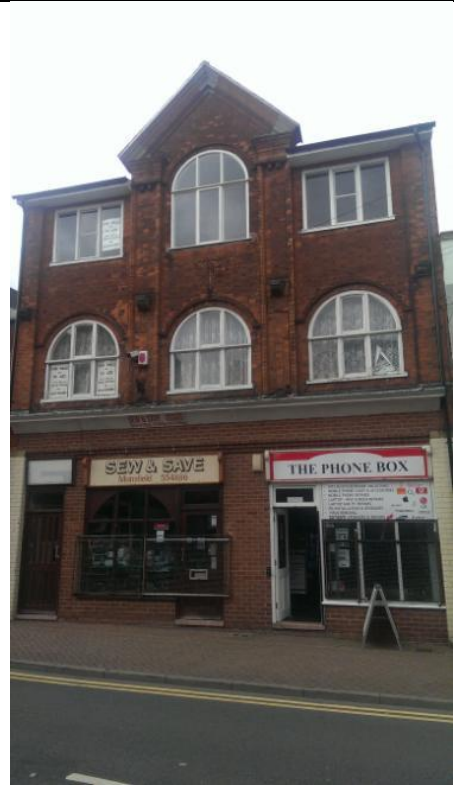
**12 King Street** is a 3 storey brick building with an artificial slate roof. Although the ground floor has been rebuilt with new shopfronts the earlier cornice has been retained. The upper floors are largely original with large arched timber windows at first floor under tile crease lintels. The second floor has a different window arrangement but dominated by the front stone coped gable which appears supported by the decorative brick pilasters. Between first and second floors are four brick corbels similar to those used to support flag pole bases.

Condition: Good.

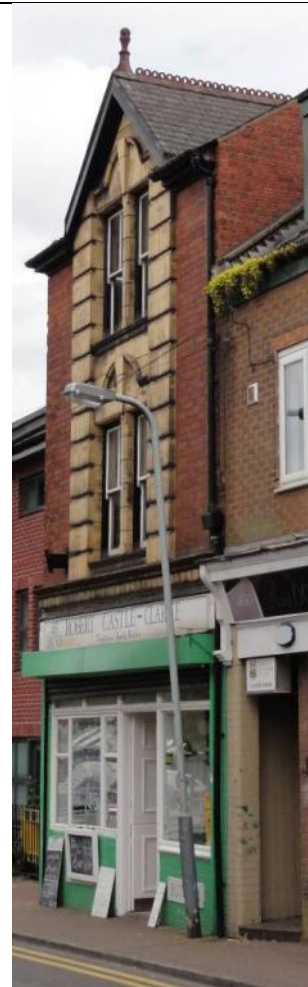
**11 King Street**, is an early 20<sup>th</sup> century c1905 3 storey building. Brick with slate roof with decorative use of stone and terracotta as can be seen with the rusticated pilasters, window mullions and general façade of the building and the ridge tiles and pinnacle to the roof. The 1<sup>st</sup> and 2<sup>nd</sup> floors retain their original timber sash windows. At the ground floor is a timber shop front of unknown date but has traditional features including the split stable style door once common to butcher shops and inscribed marble slabs affixed to the stallrisers advertising the shop as a butcher. The building also has a prominent chimney stack that served 6 fireplaces which makes it especially large.

Condition: Good.

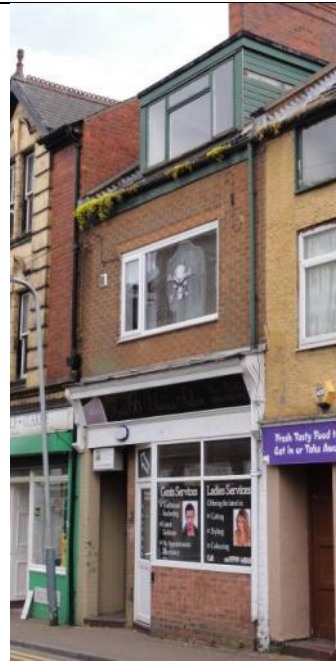
**13 King Street**, is a 2 storey building with large dormer to roof. The building is of unknown date without further investigation but appears to have a late 20<sup>th</sup> century brick façade. At ground floor an early 20<sup>th</sup> century cornice and corbels from a shopfront have been retained together with the glazed brick pilasters. Other than the remains of this earlier shopfront the building contributes little to the special architectural character of the conservation area.

Condition: Fair.

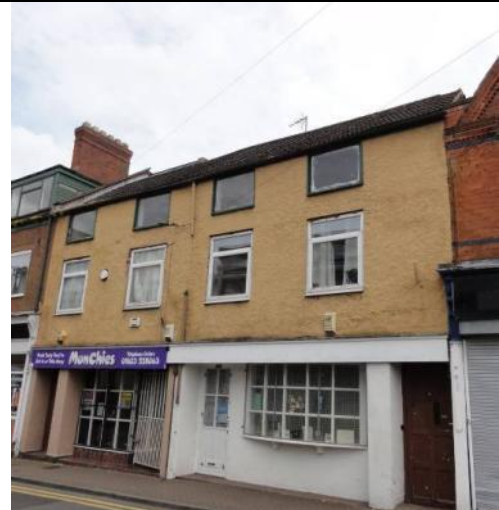
**13d-15 King Street**, is a 3 storey building of unknown date but could possibly be 18<sup>th</sup> century. The façade is roughcast rendered with modern windows throughout. The ground floor appears to have been rebuilt in the 20<sup>th</sup> century. The building in its current appearance contributes little to the special architectural character of the conservation area however a survey or stripping back of the building could reveal features of significance.

Condition: Good

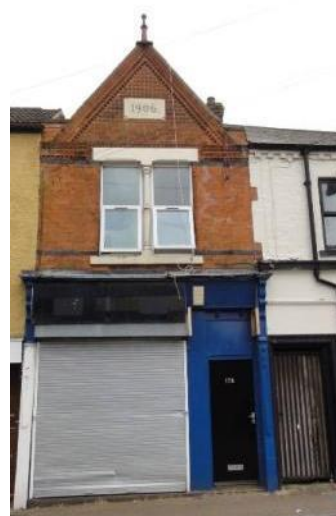
**17-17a King Street**, is a 3 storey building built in 1906 as per the date stone in its gable. The building is brick with a slate roof and uses brick decoration to embellish the façade. PVC-U windows are installed but the original centre mullion has been retained. The original shopfront survives at the ground floor but does require restoration.

Condition: Good.

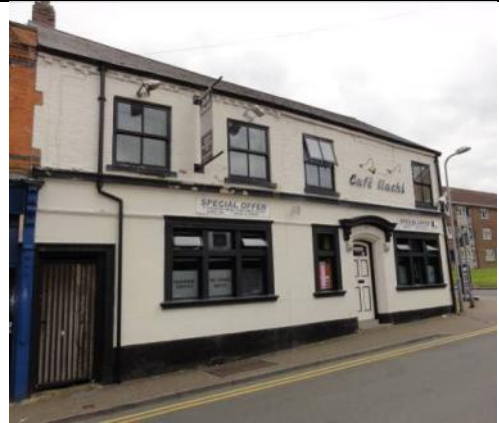
**19 King Street (Café Ilachi)**, was originally two buildings, perhaps late 18<sup>th</sup>, early 19<sup>th</sup> century albeit much altered and was formerly a public house. One of the buildings was brick the other stone, but now painted over. The ground floor is rendered with stone mullioned windows which unify the building. The main entrance door has a stone canopy which provided interest to the façade. The timber windows are modern. The demolition of buildings along King Street to create Langton Road has meant the gable to Langton Road has been rebuilt in modern brick.

Condition: Good.

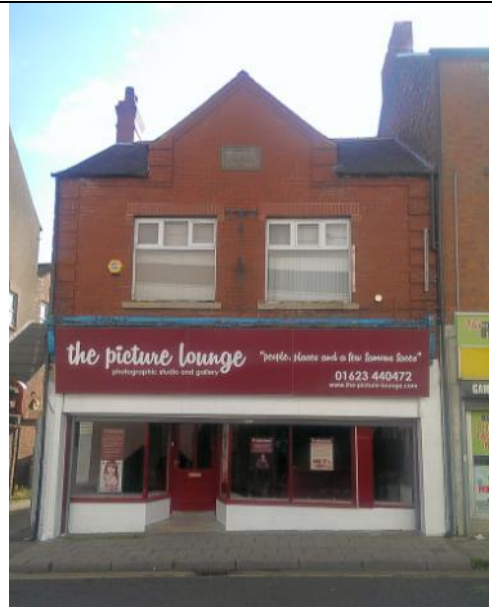
**18 Market Street**, 2 storeys, brick built, brick rusticated quoins with slate roof. Prominent front gable with date stone '1903'. First floor windows appear to be late 20<sup>th</sup> century timber replacements. At ground floor the original shop front layout with lobby entrance and remnants of original shopfront.

Condition: Good.

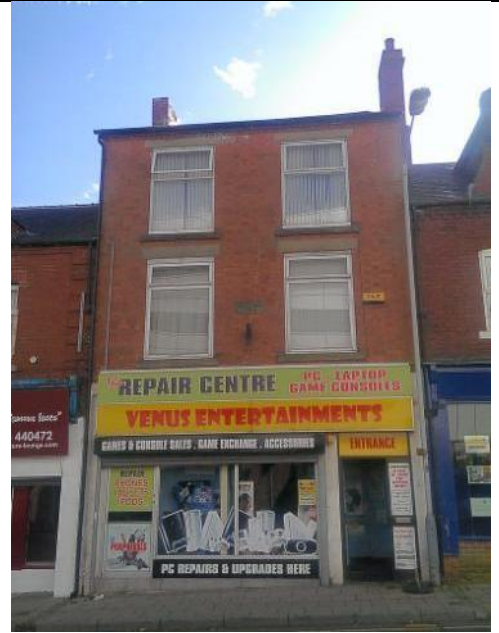
**20 Market Street**, is a 3 storey brick building with slate roof. Positioned between first floor windows is date and name stone inscribed 'Leeds House, 1923'. The building retains decorative brick work to the eaves but all windows and shopfront are modern.

Condition: Good.

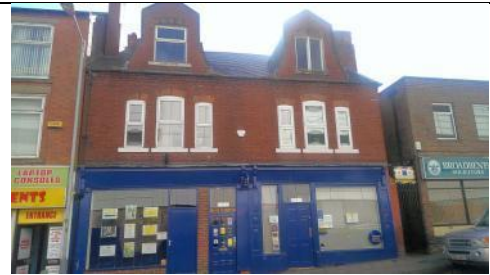
**22-24 Market Street**, is a 2.5 storey building built between 1900 -1919. Roof is covering in artificial slate. Roof benefits from unusual shaped Dutch gable style dormers. Modern uPVC windows but remnants of original shopfront survive at ground floor.

Condition: Good.

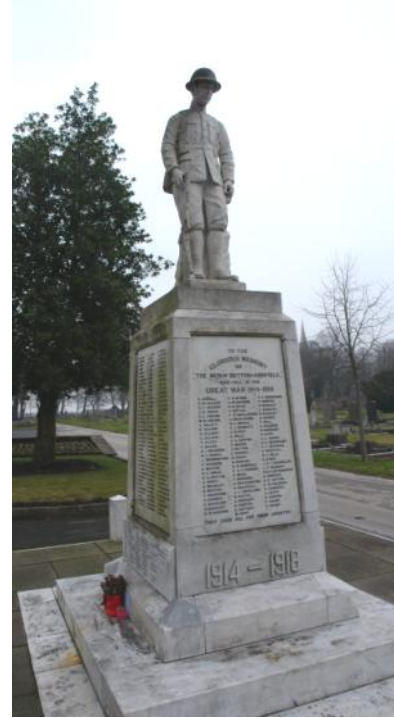
**War Memorial**, is grade II listed c.1920. The memorial is marble of a full sized soldier atop a square pedestal. The memorial is within a paved area with obelisk boundary posts linked by chains. The memorial commemorates the fallen from both WWI and WWII.

- 5.23 The war memorial was unveiled in October 1921 as a memorial to the fallen of the First World War. Further names were subsequently added to the memorial following the Second World War. The memorial is Grade II listed and is the focal point of the cemetery and its entrance.

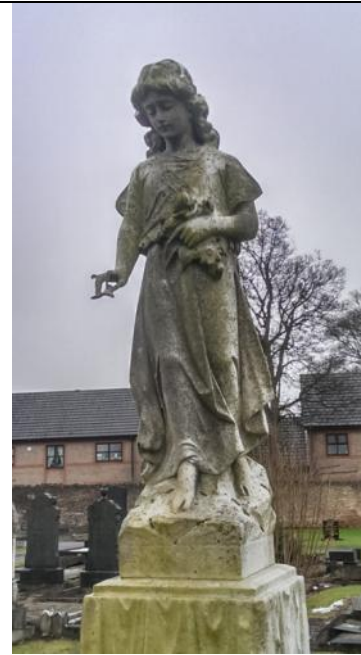
**Headstone and memorials**, more memorials were produced in the 19<sup>th</sup> and 20<sup>th</sup> century than in any other period for marking graves. Headstone and memorials would lend emphasis to Victorian cemetery design, the layout design and headstones therefore work as a whole. While it is not practicable to list every headstone of architectural or historic interest the cemetery does reflect the historical development of headstones with many having particular meanings associated to them, e.g. the angel dropping an open rose often represented the guarding of the tomb of one who died in the prime of life. Within the cemetery are a number of war graves commission headstones too.

- 5.22 As expected memorials and headstones from most eras survive but with many in poor condition, sadly however the mortuary chapel which stood behind the war memorial was demolished after the 1955 (precise date unknown).

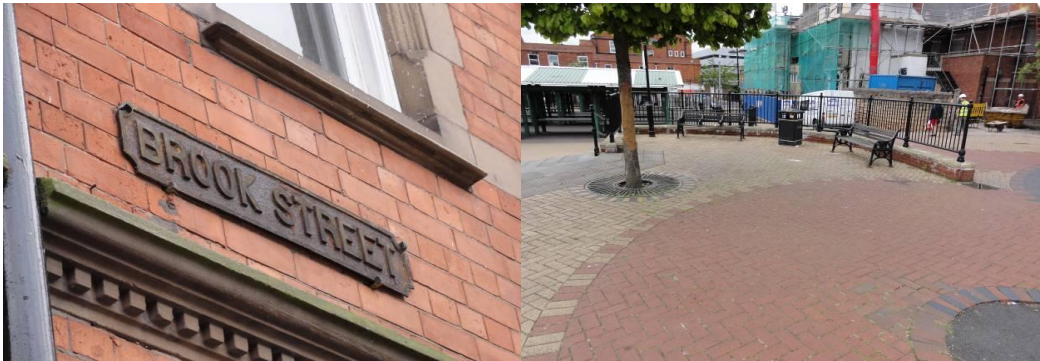
Figure 42: Left: Examples of traditional cast street name sign. Right: modern brick pavements at the market place.

5.27 Much of the public realm in the conservation area dates from the late 20<sup>th</sup> century being standard highway and pavement treatments of black top tarmac, concrete pavers and kerbs. During the late 19<sup>th</sup> century many street names changed their names, few names plaques from period have survived although evidence of where they were located can be found. These name plaques were usually pressed steel/cast iron and are features worthy of preservation or reinstatement. The market place is surfaced in a variety of materials, most notably the brick pavers laid in the 1990s when the market place was revamped.
